# General Electric E-101 Colorama Restoration

The 1936 General Electric Model E-101 "Colorama" radio has a rather unique visual tuning aid using red and green panel lamps which illuminate the dial scale. The relative brightness of the red and green lamps change depending on whether the radio is tuned to a station or not. Colorama sets were available in both table model and console sets with various numbers of tubes and features.

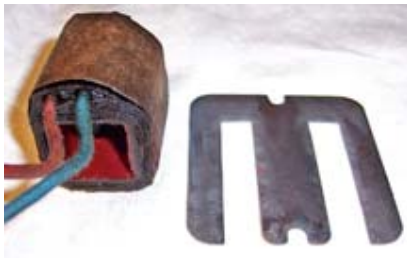
Shown here is the primary coil and one of the laminations.

- Removed the metal wedge between the primary coil (center coil) and laminations using small metal ruler. This wedge is the only thing holding the reactor together. Unlike Kim's situation, there were no nuts and bolts holding it together.
- Once the wedge was out, I was able to coax out the top lamination and then the remainder of the laminations, one at a time. All laminations were E type, back to back - no I sections, no gap or lacquer obvious.
- Removed the primary and two secondary coils and did additional cleaning of coils and laminations using Naphtha and toothbrushes
- The two secondary coils (30 ohms total) were OK. Later I had to secure the paper wrappers on the secondary coils using hot glue (the Naphtha soak had likely loosened the glue).

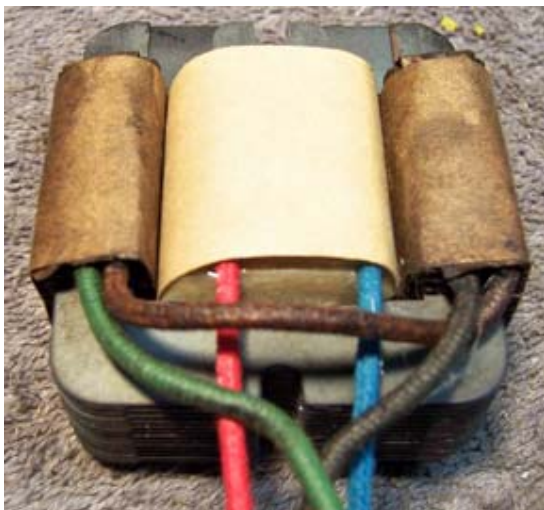
Assembled reactor with replacement primary and original secondary coils.

I then obtained a replacement primary coil from Kim Herron (wound by Heyboer Transformer). It measured 1760 ohms - the original was 2049 ohms. I reassembled the reactor using the replacement primary and original secondary coils and replaced the wedge securing the assembly.

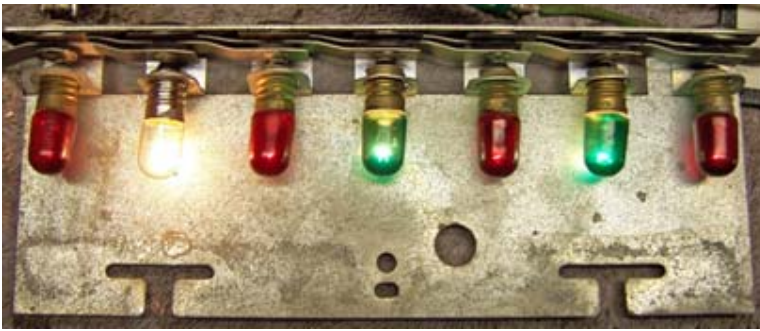
With no current in the control winding, the Green lamps were ON full and the Red lamps were dim (one burned out Green lamp was temporarily replaced with a clear bulb for testing).

The next step was to test the reactor before installation in the radio. I used the AC lamp supply from the set's power transformer (about 30 volts unloaded) but reduced the AC input using a Variac until the filament voltage was about 6.3. The lamp supply was then about 24 volts. I used the two original 15 ohm resistors (R29 and R30) in the set. I reconnected the original wiring to the lamp holder assembly and installed the Colorama lamps. I then arranged a variable DC supply for the primary or control winding, with a DVM in series to measure the current. My [reference document](#) gave two reference points: 11ma and 0ma. 1760 ohms at 11ma means that the variable DC supply needed to be about 20 volts max.

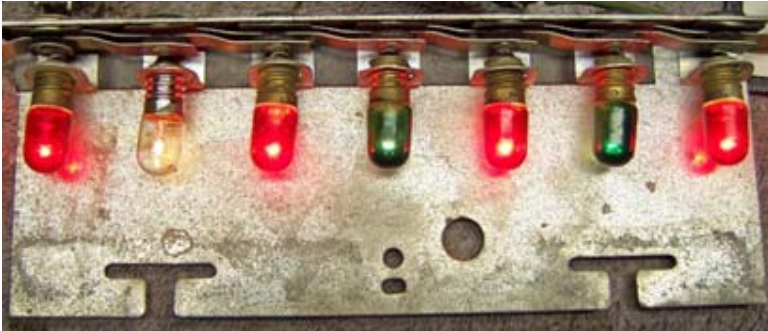
With 11ma on the control winding, the Red lamps were ON and the Green lamps were dim. The Red lamps peaked at about 7.5ma and only increased slightly in brightness at 11ma.
