Bush BAC31

This "Recent Repair" was kindly contributed by Tim Pullin.

Portable for use with dry batteries (90V & 7.5V) or AC mains with an optional
Bush No. 42 power unit.

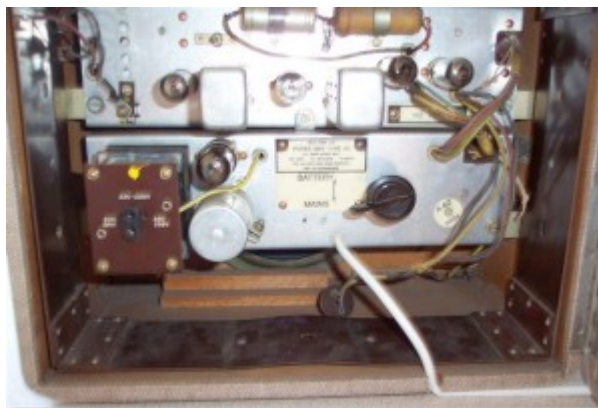
The 2.2 Meg ohm screen grid resistor was within tolerance, but the 0.05uF wax paper de-coupling capacitor (C20) was found to be extremely leaky, so too much voltage was being dropped by the screen grid resistor, leaving a lower than expected screen grid voltage. The leakage through the capacitor was so severe it was easily measured on the x100 ohms range of a standard meter. A replacement capacitor brought about a transformation at the next test, with the little set now producing lashings of fair quality sound, (I actually had to turn the volume down!!) and a few stations that had previously been inaudible. I was going to replace the wax capacitors as a matter of course, but it is good to find a fault properly sometimes and keep one's "hand in".

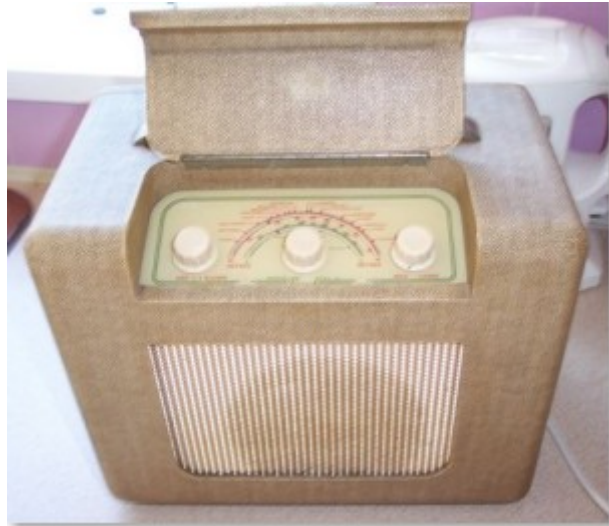
The remaining wax capacitors were tested as they were removed during the renewal process, and all proved to be leaky. The "next worst" in leakage compared to the DAF91 screen grid de-coupler was a large 0.5uF mounted on the top of the chassis, to provide AC bypass to the valve filaments. Since the set was likely to be opened frequently in order to stash the mains flex, this capacitor and a metalised paper type adjacent to it were left in situ

for aesthetic reasons. The connecting wires to the capacitors cut near their

connecting tags below the chassis and the wire left in situ to preserve the upper chassis appearance. Both were replaced electrically by smaller modern types located under the chassis.

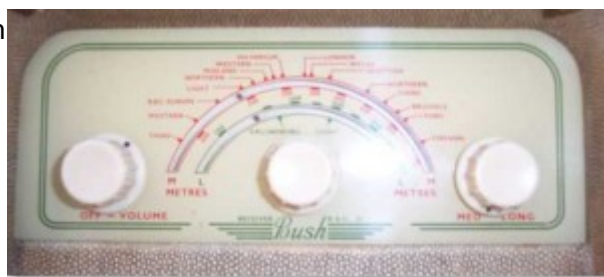
Since the chassis was already out on the bench, it would not require much additional effort to clean up the tuning scale and knobs. The pull off knobs proved to be very stiff, thwarting all attempts to remove them by the usual "string" method. In the end I crossed my fingers and gently prised them off with a

medium flat blade screwdriver. The tuning scale was then removed and the backing plate carefully brushed to remove the dust and wiped with hand cleansing tissues, which restored the original cream finish extremely well. Baby wipes were used for cleaning the back of the printed Perspex scale, as they remove dirt with hardly any rubbing. I noticed the front of the frame that supported the scale was bent. It was easily straightened by hand though and the scale re fitted. Both chassis were replaced in the case, and connections made via plug and sockets.
